Thermography with VARIOSCAN

Building inspection

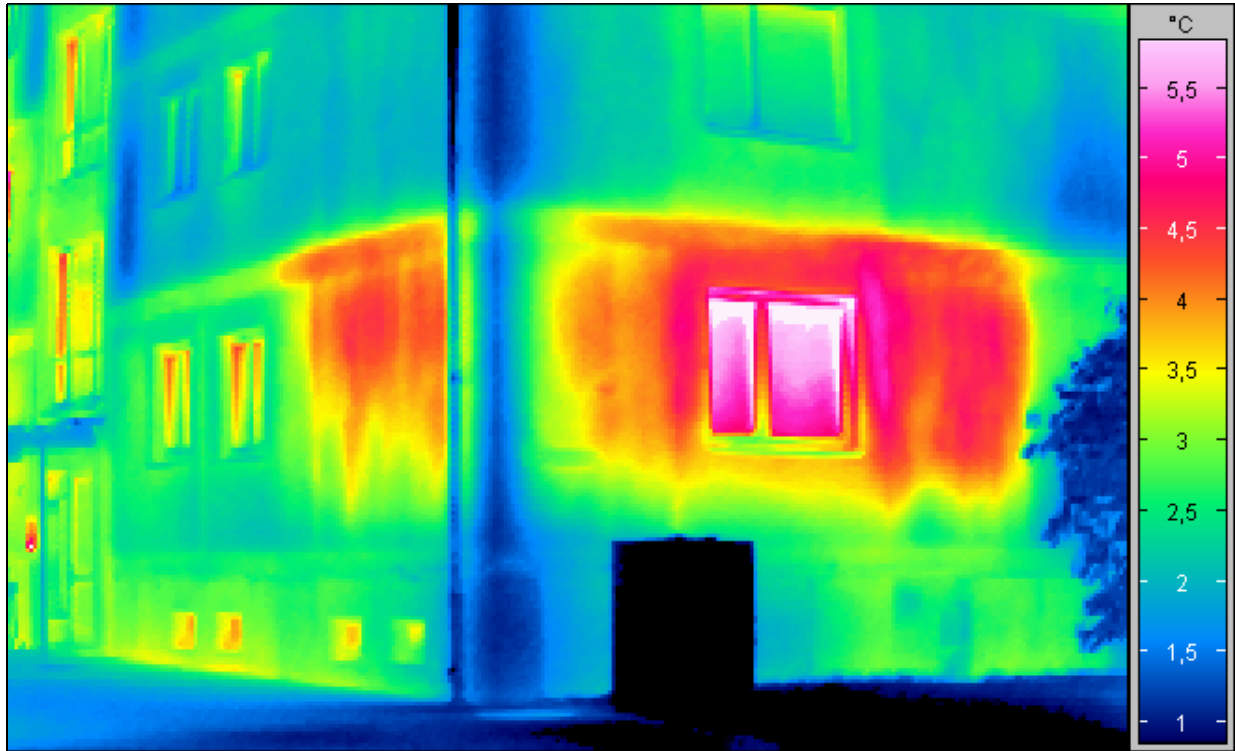
Insulation defects before reconstruction

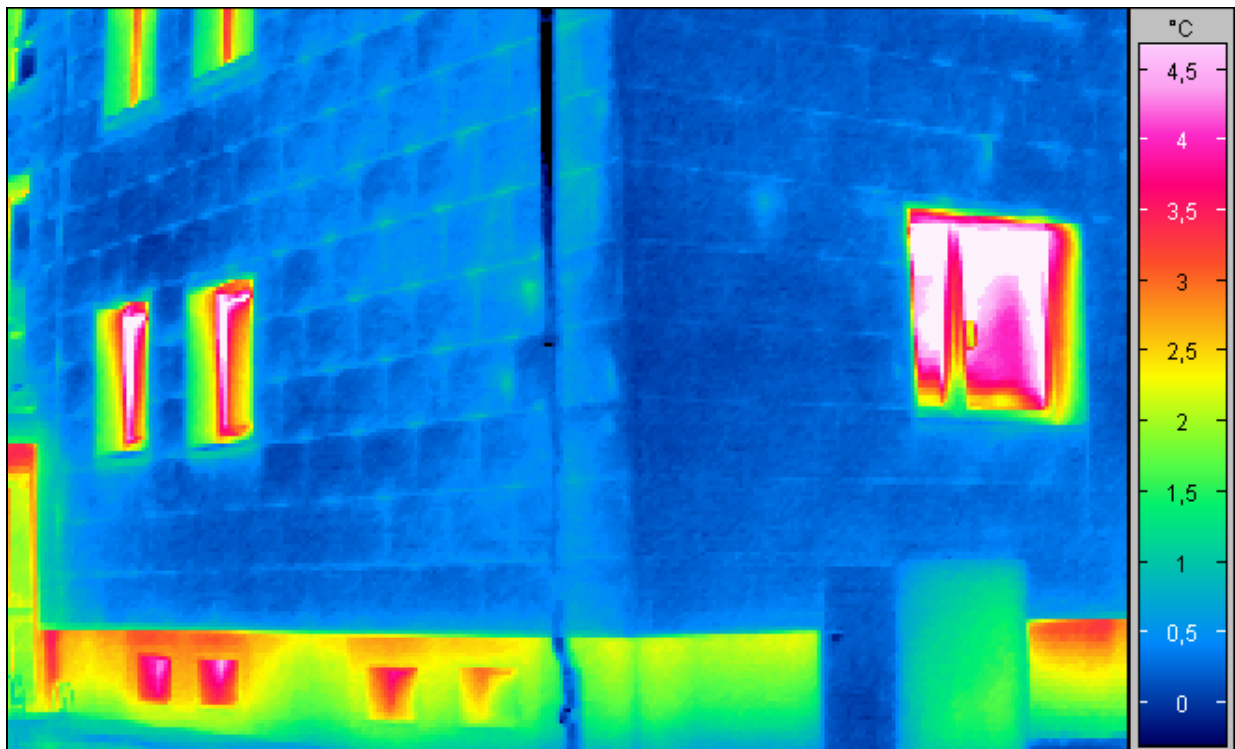
Building after reconstruction. Further existing lacks: poorly windows and no insulation of the basement
